Wild Trout Trust Habitat Advisory visit
to the River Annalee, Co. Cavan, Eire.
Undertaken on behalf Cavan Anglers'
Club, by Vaughan Lewis, Windrush
AEC Ltd
April 2011

1.0 Introduction

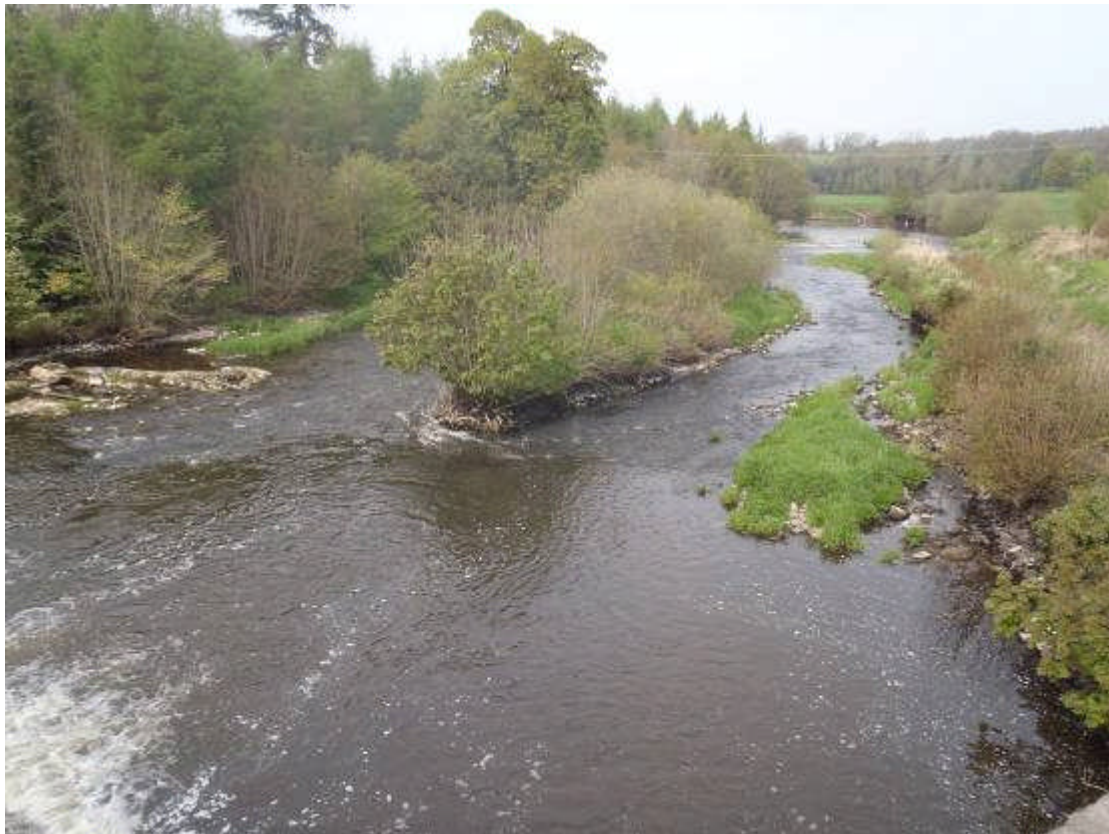
The clubs stretch of the Annalee splits into two broad habitat types. The first comprises sections with a good gradient, a well defined pool and riffle regime, and a substrate dominated by gravel/cobble/boulder habitat. In short, excellent general habitat for trout. The remaining (larger) percentage of the river is dominated by slow, deep sections, more suitable for adult trout and coarse fish.

Section of excellent habitat on the Annalee

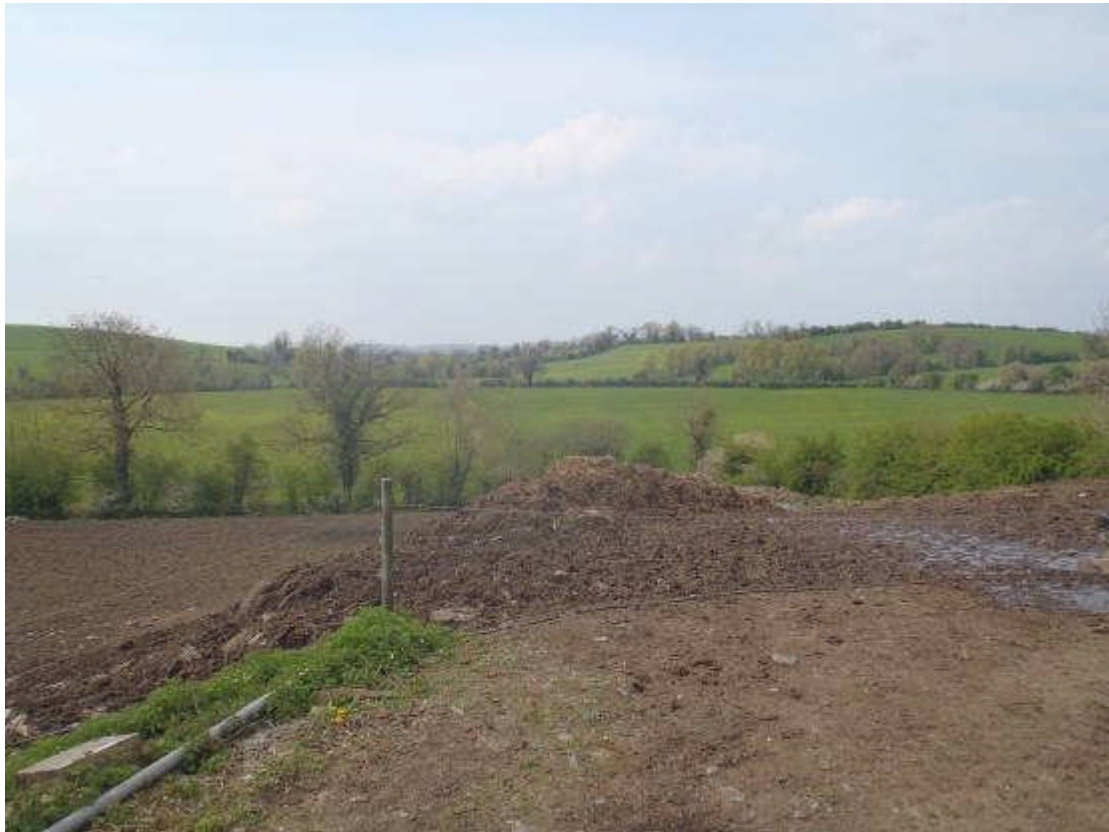
The river has generally good water quality, although there have been serious pollutions in the past, including a discharge of agricultural slurry around 20 years ago that resulted in a significant fish mortality. The chronic impact of agriculturally derived enrichment was clear from the growth of diatoms and filamentous algae on much of the river bed. Poor agricultural practices were also very evident at isolated locations along the reach (see photo below)

Overgrazed land and slurry run-off (right of shot) in a field above an Annalee tributary stream

- Typical issues that should be addressed include the location of slurry pits, and silage clamps, overgrazing of riverside fields, run-off along pathways/farm tracks and the application of excessive fertilisers on fields draining to the Annalee. Further information is provided in the WTT Upland Rivers Habitat Manual available as a PDF www.wildtrout.org This is not an easy problem to tackle but with some determination, farmers can be engaged to tackle these issues, particularly if suitable financial incentives can be identified.

- Fencing of the river bank, either seasonally or permanently is vital to reduce the damaging impact of the large numbers of cattle present. There is also a need to provide a clean water supply once fencing has been erected, probably by the construction of well-designed cattle drinking areas. Fencing should ideally be erected at least 5m from the river in order to create a well vegetated buffer strip capable of reducing erosion and minimising run-off from the adjacent fields. Densely vegetated buffer strips of this type will also benefit other key species including otter, hence increasing its general value to wildlife interests.

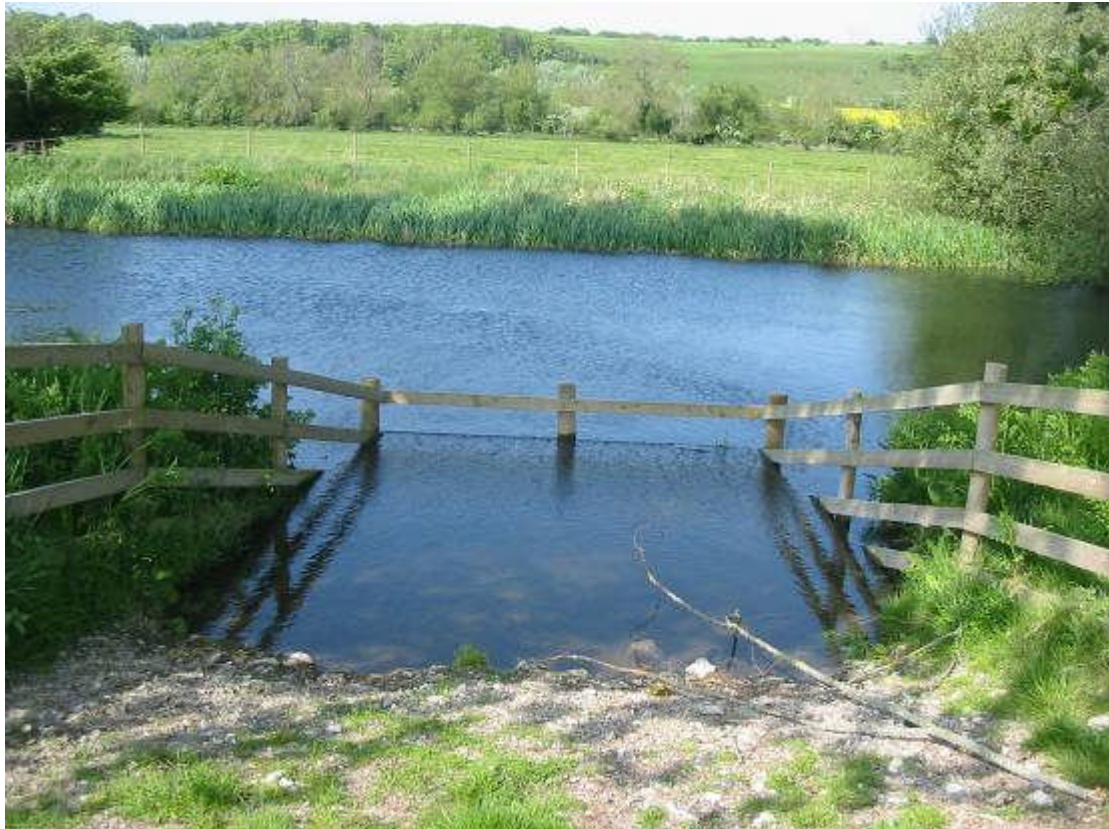
Well designed cattle drinking area

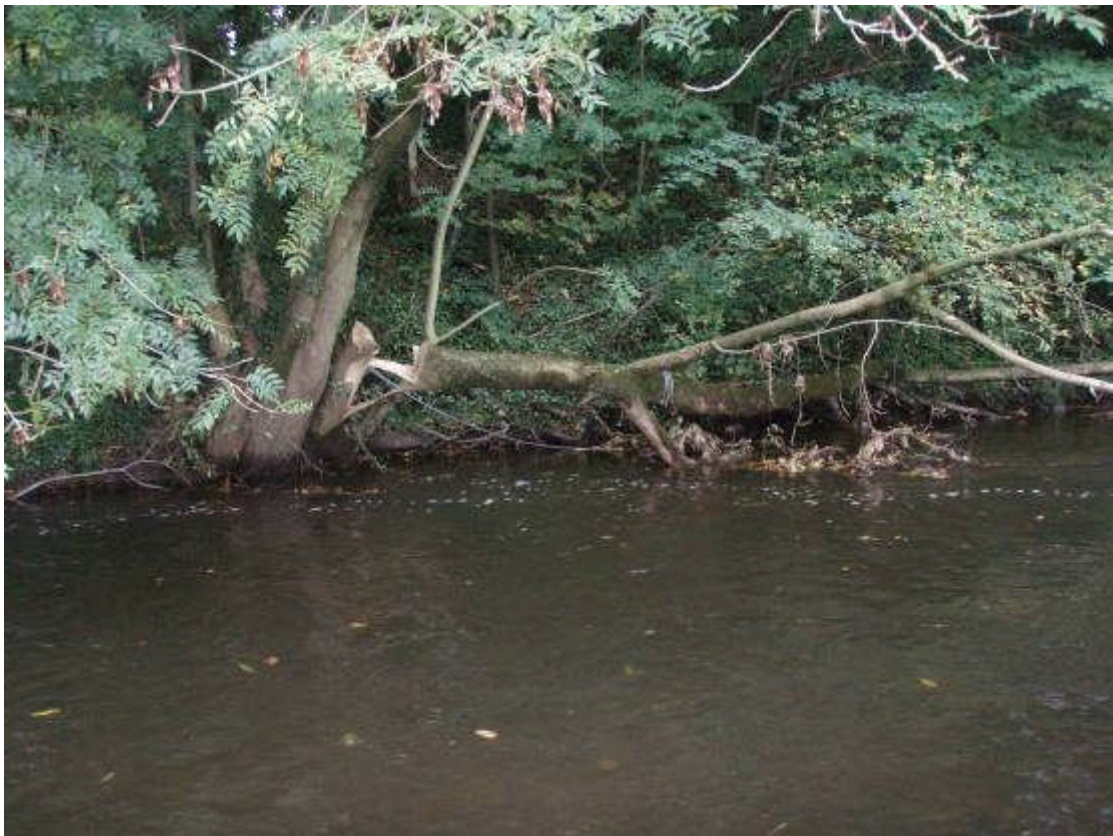
Cut, hinged and wire anchored LWD

- In contrast, there are a number of very simple enhancements that can be undertaken in the areas of shallower water that will greatly benefit trout, particularly the juvenile life stage. ‘Cutting and hinging’ trees is an easy operation that will provide increased marginal cover, help scouring of the river bed, provide food for shredding invertebrates and help retain damaging fine sediment. Careful selection of suitable trees should be carried out, ideally adjacent to areas of shallow, gravel bedded water where the benefits will be greatest. Cut through two thirds of the trunk and then push it into the water. Anchor using reinforcing bar driven into the bed through pre-drilled holes (Care! Check for buried services first) and cable laid wire around/through the trunk to the section of rooted trunk remaining on the bank. An additional benefit of selectively felling trees is that shade will be reduced locally, increasing the growth of plants and their protection of the bank from erosion. More details are provided in the WTT Upland Rivers Habitat Manual
